N.C. Division of Coastal Management
Assessment of 27 Marsh Sills in North Carolina
Final Report

Prepared by: John Fear, Ph.D. and Bonnie Bendell

April 2011

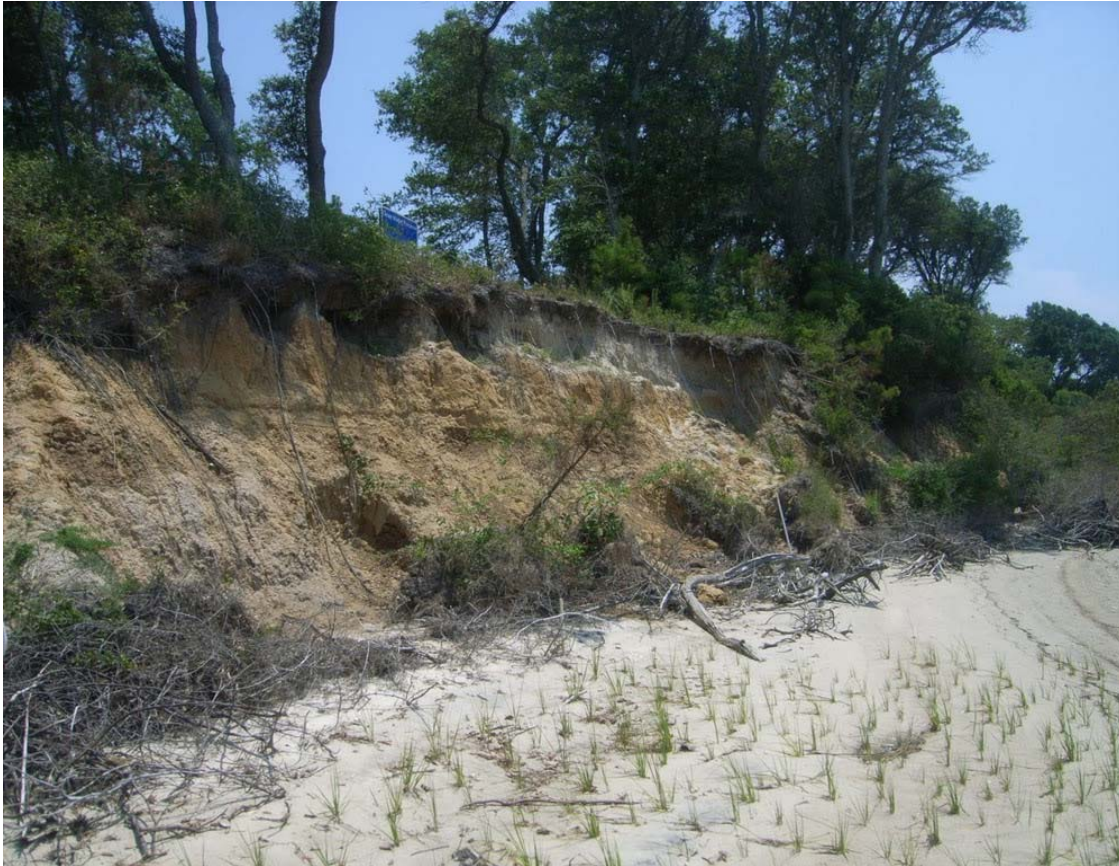
This finding is based on the responses of the field team to questions 9, 21, and 43 of the field datasheet (Table 3), the agency letter from DMF, and the responses of the property owners to property owner survey questions 4, 5, and 6 (Table 4). The field team noted 61 percent of the time that erosion was not occurring on the properties protected by marsh sills. Of the remaining responses, 13 percent of the time the field team was unsure and 25 percent of the time evidence of erosion was observable (Table 3, question 9). However, this does not imply that erosion was actively occurring at seven (25% of 27) of the visited marsh sills. One limitation of this study was that it did not account for the temporal difference between when the marsh sills were installed. Some of the visited marsh sills were more than ten years old, while others were recently constructed. The field team was only afforded a one-time snapshot view of the marsh sills. As such, it was not possible for the field team to assess when the observed erosion evidence actually occurred. There was only one site where the field team unanimously agreed that evidence of erosion existed, at project 47-09, the Jones Island marsh sill site in Onslow County. This marsh sill is newly constructed and sits in front of a pre-existing high bank bluff (Figure 3). It was the presence and condition of this bluff that the field team noted as evidence of erosion (Appendix 8.1, page 120, question 10).

Figure 3: Eroding high bank bluff with marsh plantings in front at Jones Island, Onslow County.

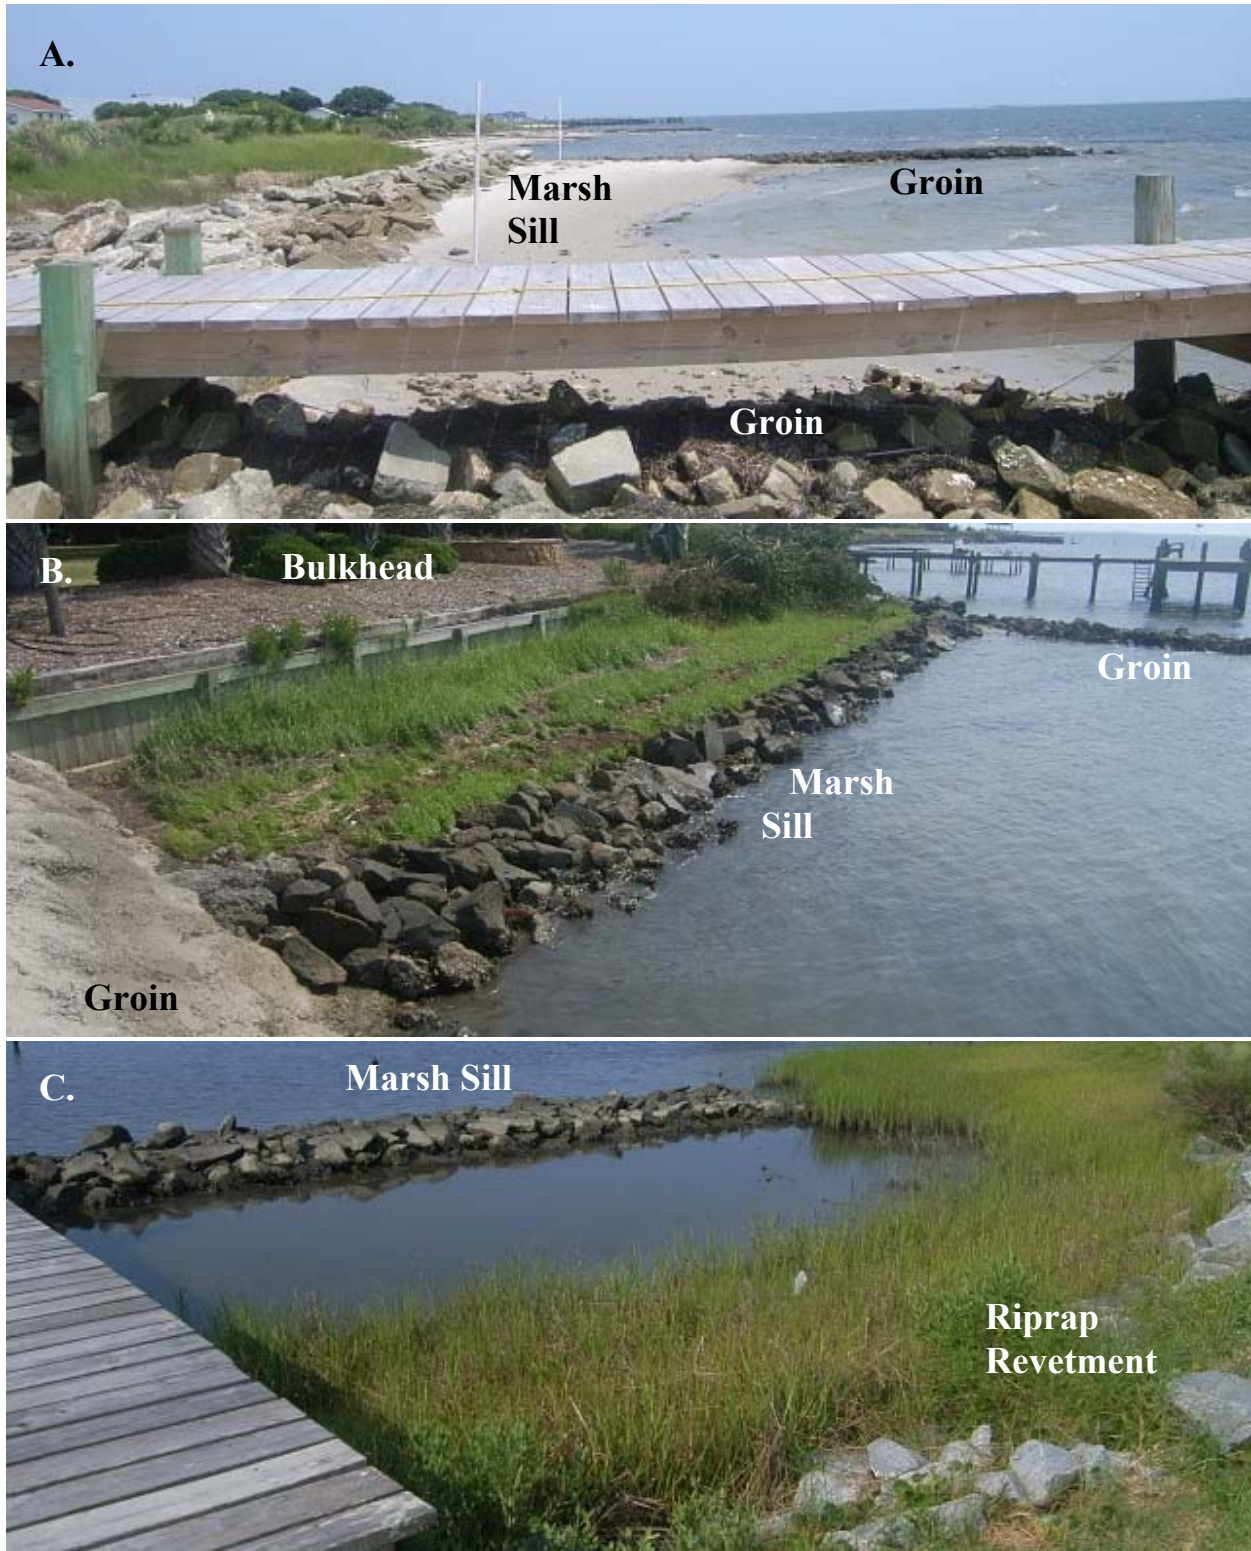
This finding is based on visual observation from the field visits. Of the 27 visited marsh sills, 12 of them (44 percent) were built in front of or attached to another type of shoreline stabilization. Most commonly observed were marsh sills built in front of bulkheads, or in combination with groins. Figure 4 shows examples of several marsh sills built in combination with other stabilization structures. The interaction of several shoreline stabilization structures operating synergistically is a much more complex situation compared to a marsh sill by itself. The design process and potentially the permitting for marsh sills must account for the potential interaction between two or more shoreline stabilization methods utilized at the same place and time.

Figure 4: Marsh sills built in combination with other stabilization structures. Panel A: marsh sill and groins; Panel B: marsh sill and groins in front of a bulkhead; Panel C: marsh sill built in front of a riprap revetment.

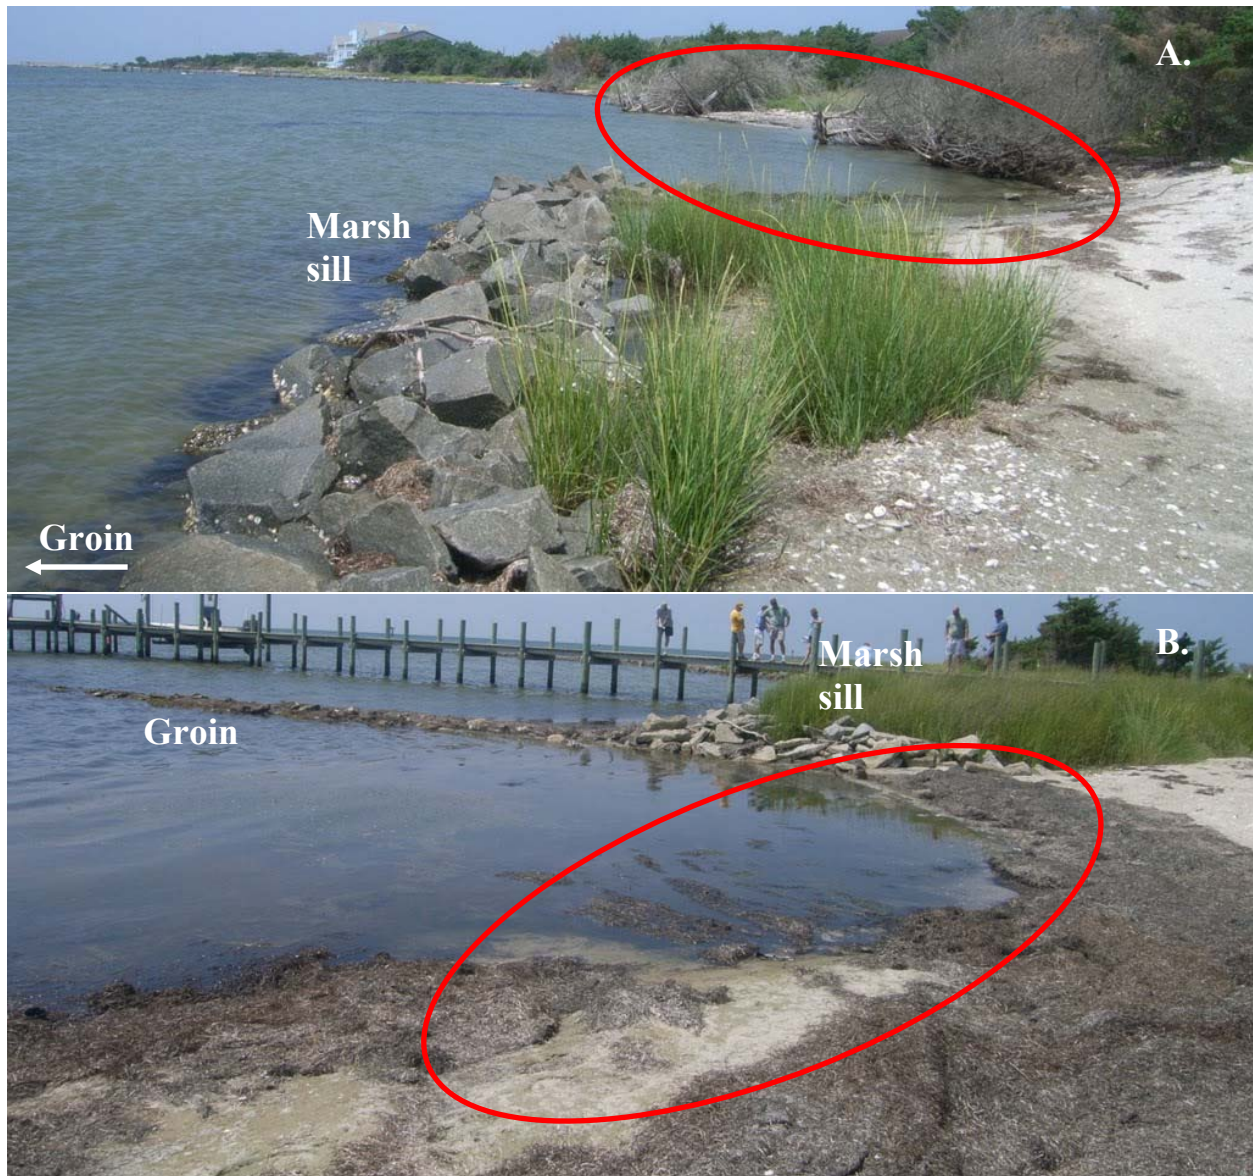
Several different areas of erosion on the adjacent properties were noted by the field team at site 46565B (Appendix 8.1, page 93, question 12). However, the field team was unsure if the erosion was being caused by the marsh sill or the two groins present at the site, as most of the erosion seemed to be occurring near where the marsh sill joined with the groins (Figure 6).

Figure 6: Erosion on adjacent properties of project 46565B. Panel A shows a picture of the adjacent property to the north taken from the junction of the marsh sill and one of the two groins. The groin extends off picture to the left as indicated by the arrow. Panel B is taken from the adjoining property to the south and shows where the other groin joins the marsh sill. The red circles on both panels show the areas of erosion.
