N.C. Division of Coastal Management
Assessment of 27 Marsh Sills in North Carolina
Final Report

Prepared by: John Fear, Ph.D. and Bonnie Bendell

April 2011

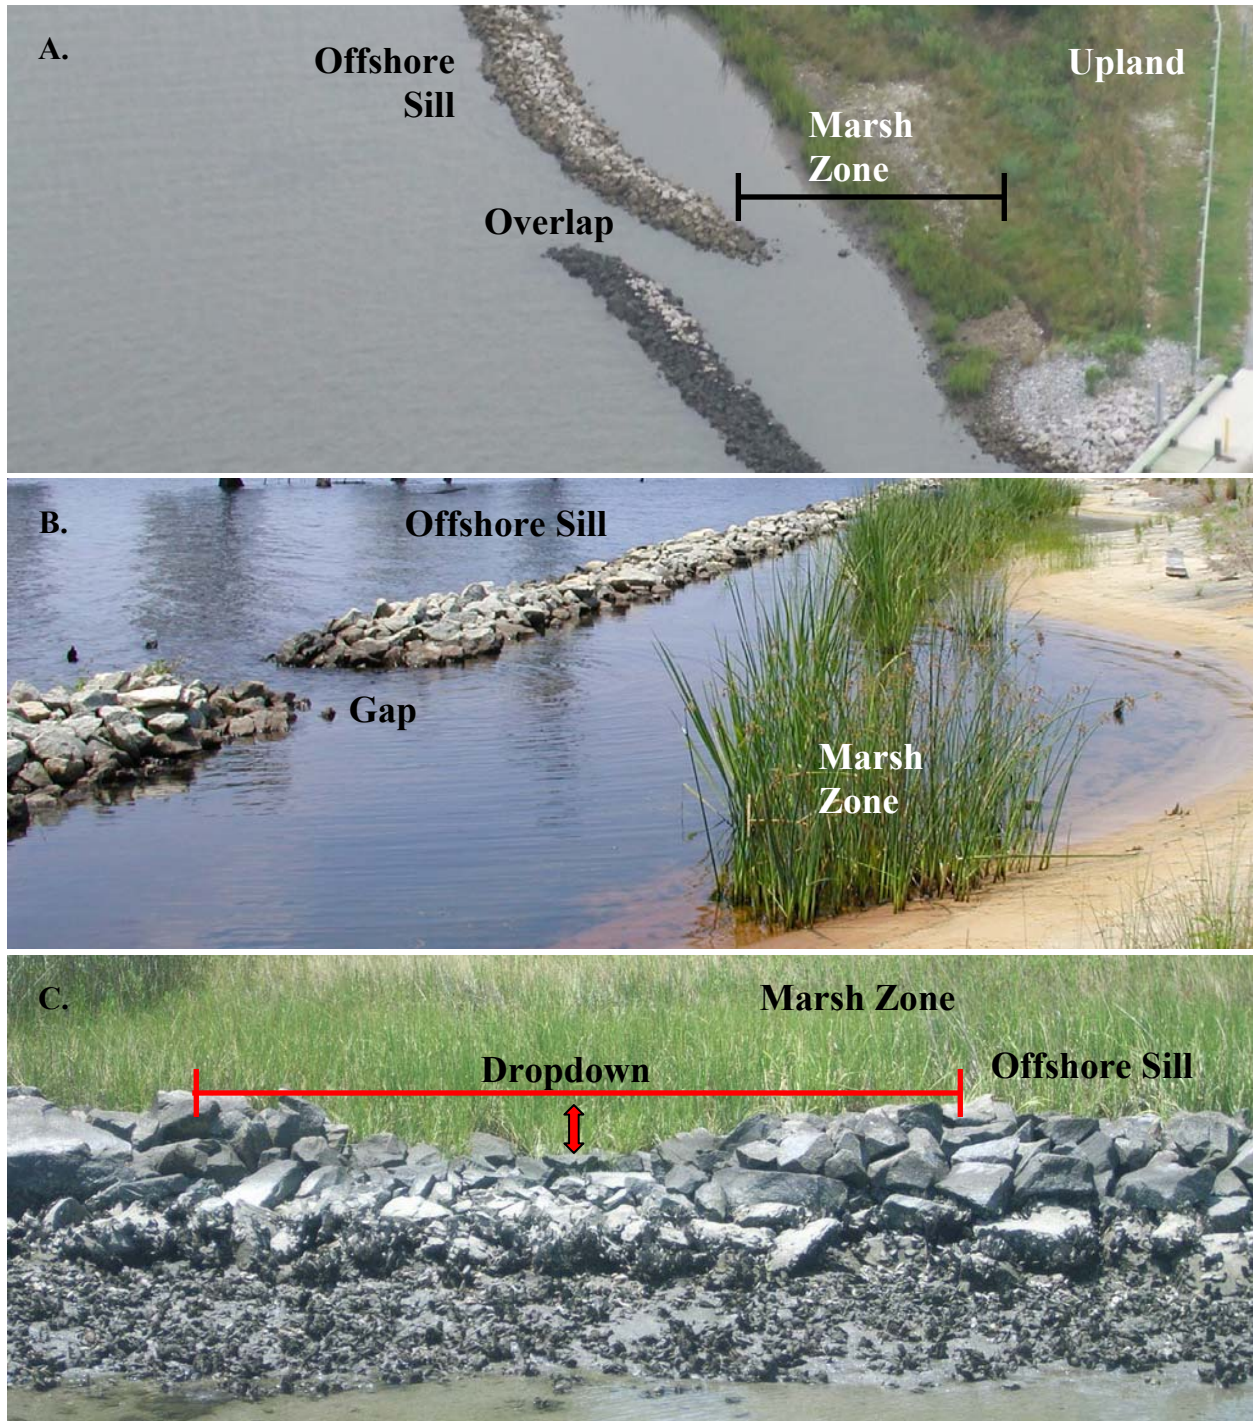
Figure 1: Labeled marsh sill design elements. Panel A depicts the overlap design, panel B the gap design, and panel C the dropdown design. The red lines and arrows in panel C show the vertical relief of the dropdown area.
